TOP counter

Intro. and status

K. Inami
2015/5

TOPカウンター

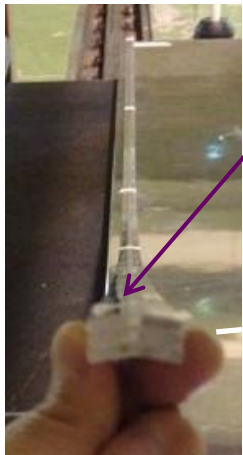
Integrated 16 modules

QBB design requirement:
- rigid support with low material budget
(max. sag ≤ 0.5 mm based on MC)

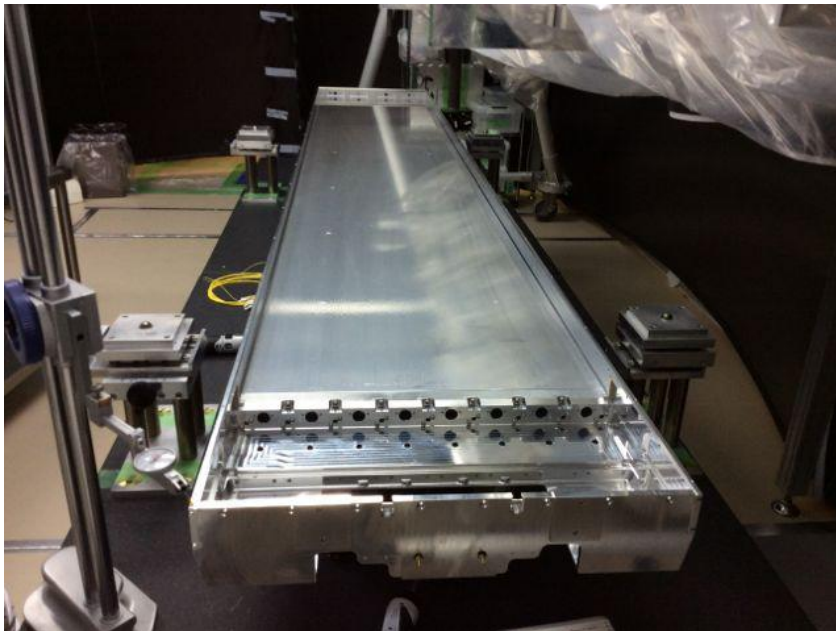
QBB preparation

- Measure flatness of the honeycomb panels.
- Attach strong-back, tune and test stability.
- Assemble enclosure
 - Align inner-panel and enclosure $< 0.06\text{mm}$.
- Install LEDs, cameras, spring holders, fiber holders

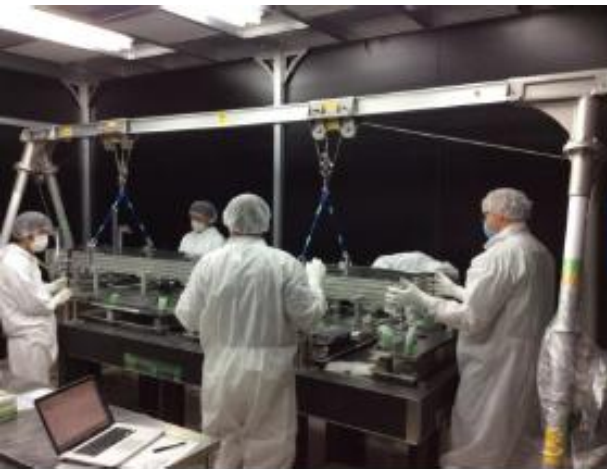
- Successfully lift up dummy glass from gluing stage to QBB stage
 - Need to refine crane path, flooring
 - Small improvement to make easier operation
- Touch down to QBB
 - Need to check clearance
 - Need many jigs to guide quartz
 - Check assembling procedure after cups off

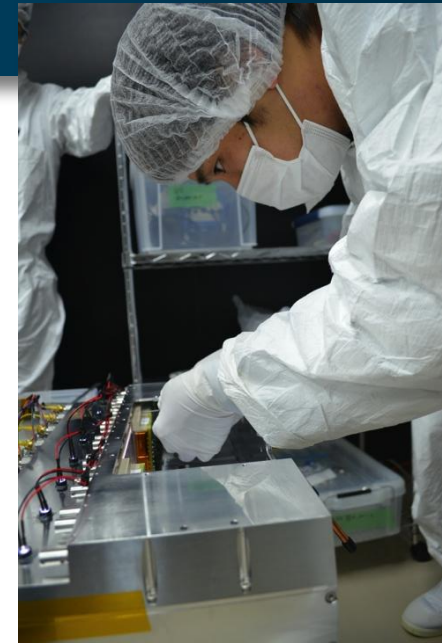
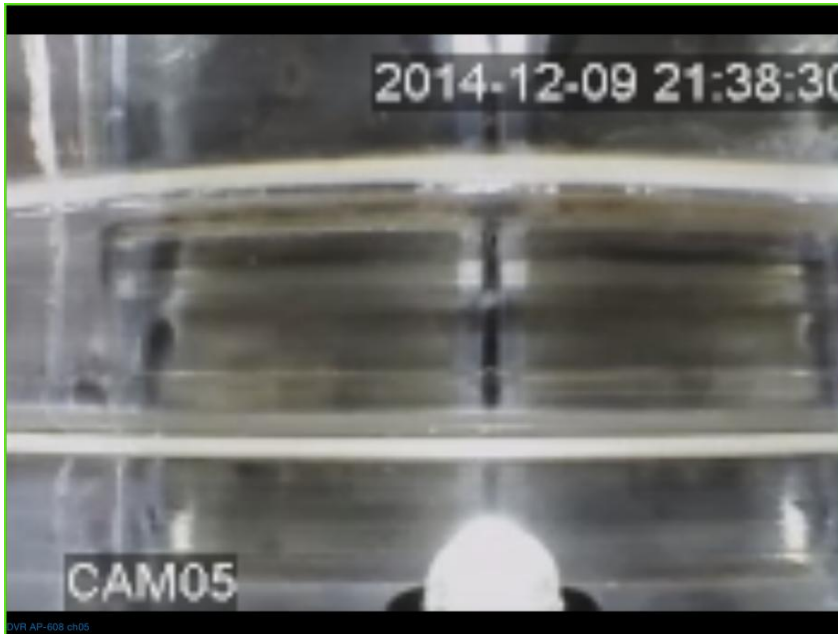
PMT module mounting

- After PMT module assembling and Silicone cookie preparation, PMT modules are mounted into the TOP module.
- Goodness of optical contact is checked by CCD camera image.
- Successfully done all modules after small modification.

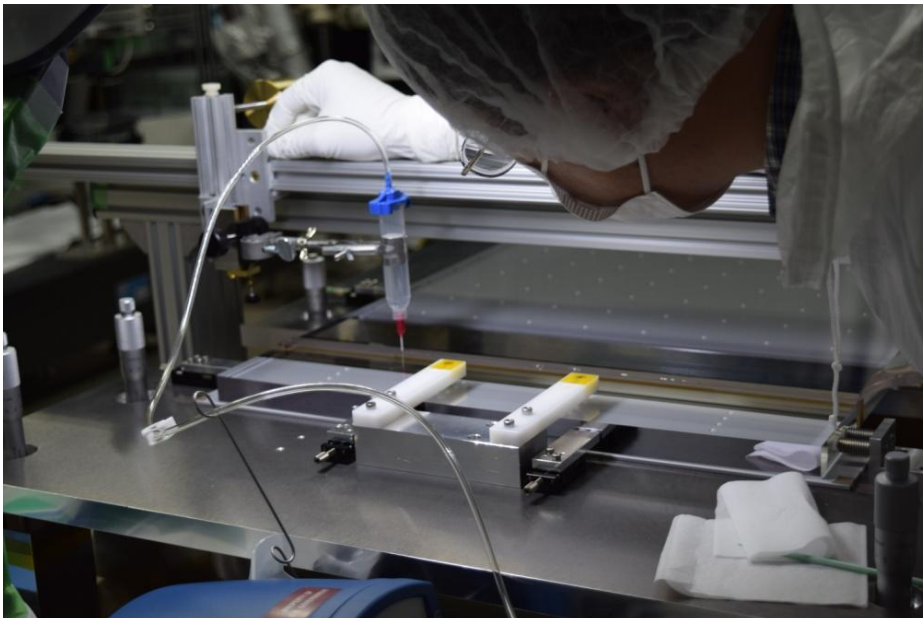
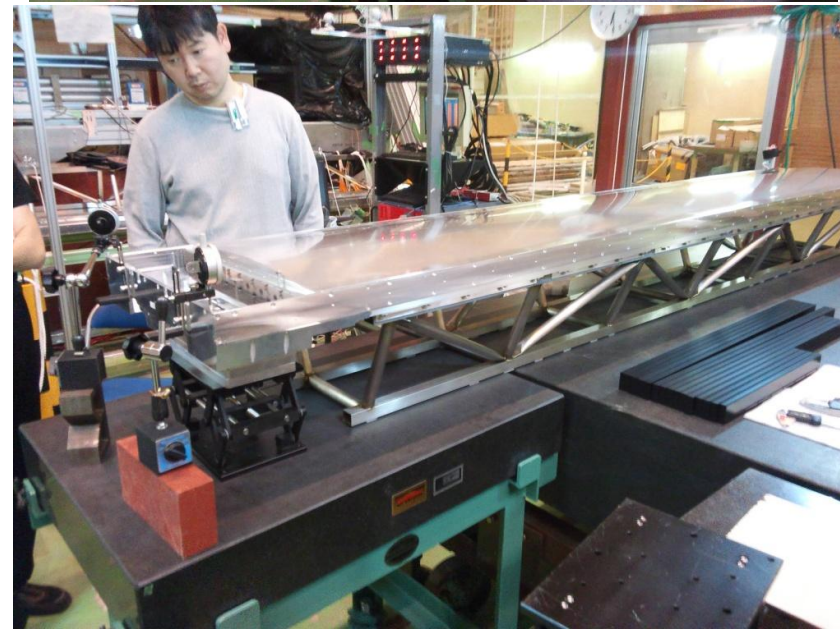
- Glue/assemble from March.19
 - With updated procedure
- Quartz alignment/glue went rather smoothly.
 - Made new technique for glue joint taping
 - Still weak index fluctuation appeared, but much improved from module01
- QBB flatness and button glue was done within the targeted tolerance ($20\sim 30\mu\text{m}$).
- Need to update the procedure further

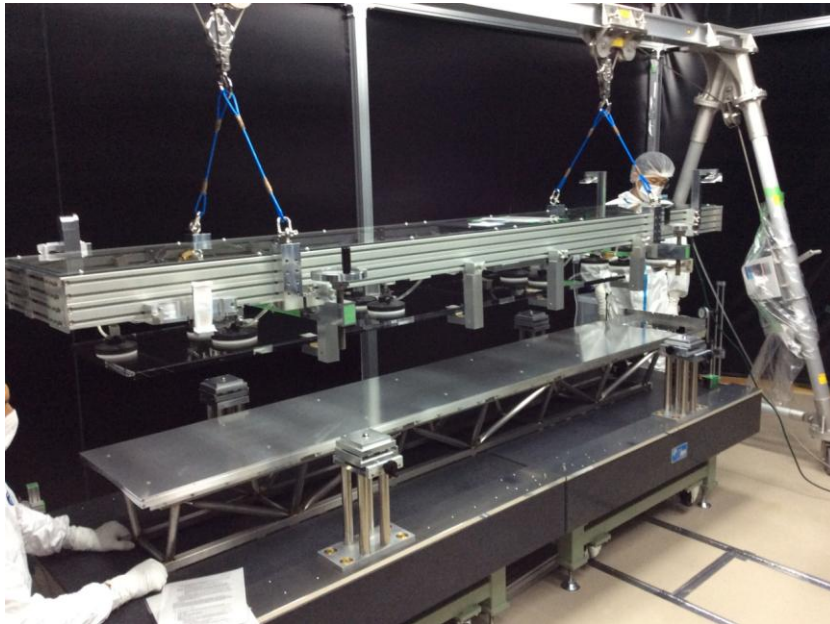
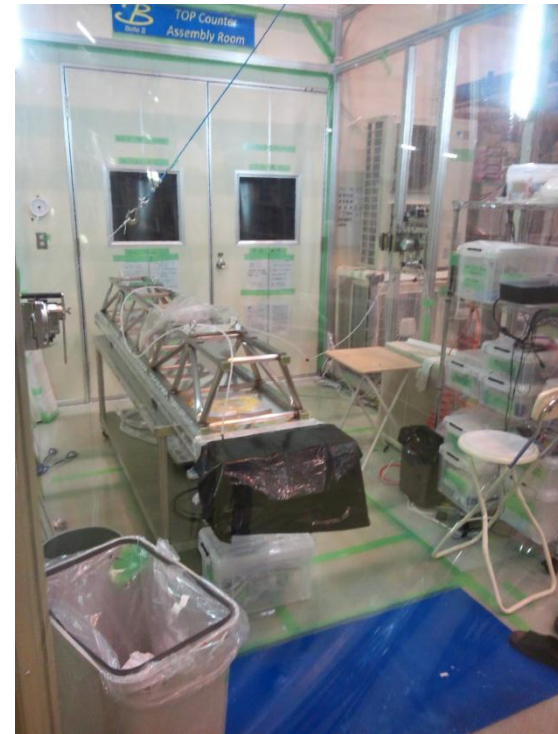
- Finish up to initial gas sealing within 2.5 weeks
 - Quartz cleaning, lift up quartz, QBB assembly, gas sealing was done.
 - Moved to Buffer2
 - Gas leak test is underway.
 - Put silicone on screw holes, keyway between side rail and enclosure
 - Improved to 80% of return gas, but still large leakage inside enclosure
 - Continue to fix

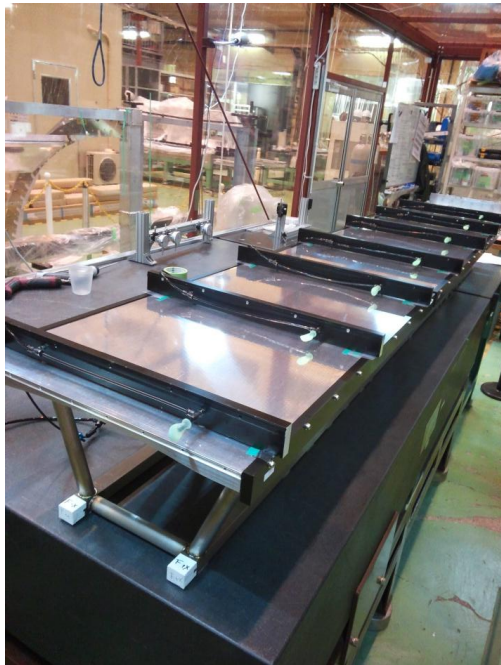
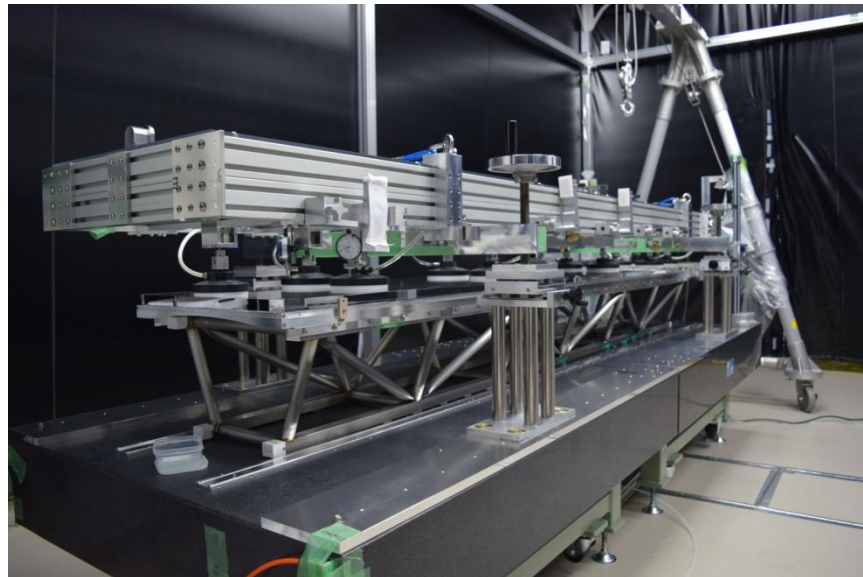
- QBB prepared
 - Careful dry fitting and tuning of inner honeycomb panel, strong back and enclosure. Still need some improvement to make the procedure easy
 - Tried new button gluing method. Works well and easy. Button flatness is ± 10 micron level.
- Quartz-QBB assembling
 - Almost done. Gas sealing check continuing.

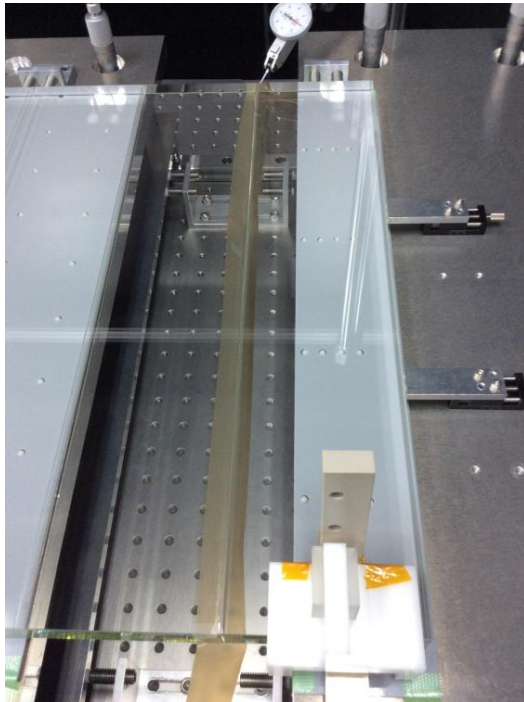
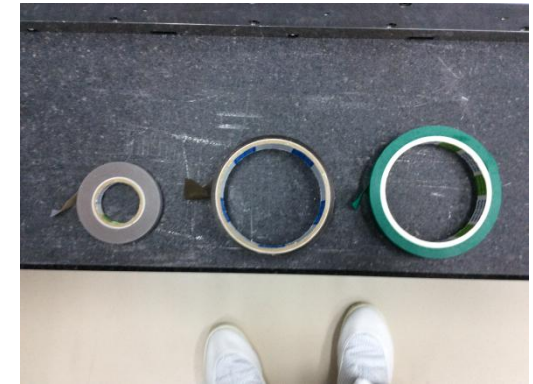
Taping method development for EPOTEK

- Striae like structure was appeared in the case of glue leakage. We need to improve the taping method for the stable glue curing (better strength).
- Teflon tape (softer than Kapton tape) for mirror part
- Test Teflon block and tape for prism part with glue
 - Difficult joint due to the difference of width
 - Prism (456mm), bar (450mm)
 - Trials look OK. No leakage happened for 4 trials.
