# Optics and module assembly +MCP-PMTs

K.lnami

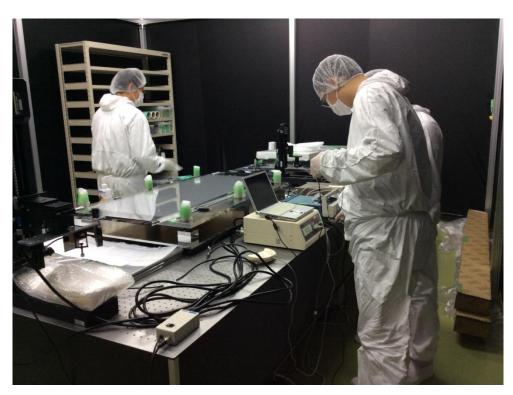
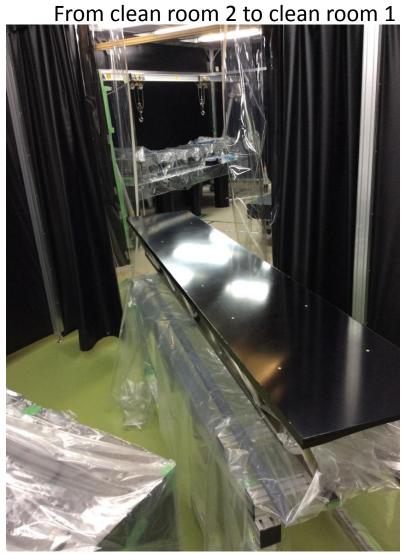
## Clean room for quartz assembling

- Quartz acceptance test at room2
- Quartz glue at room1
- Optics and QBB assembling at room1
- Clean level is 100~1000.

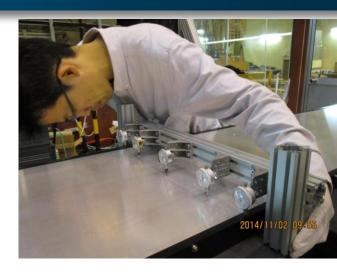
#### QBB preparation

- Measure flatness of the honeycomb panels.
- Attach strong-back, tune and test stability.
- Assemble enclosure
  - Align inner-panel and enclosure < 0.06mm.</li>
- Install LEDs, cameras, spring holders, fiber holders

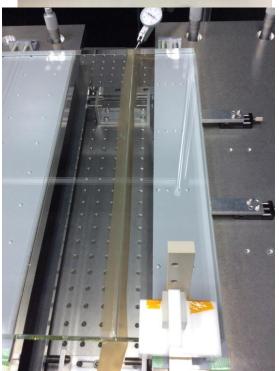
## Taping method development for EPOTEK

- Striae like structure was appeared in the case of glue leakage. We need to improve the taping method for the stable glue curing.
- Use Teflon tape (softer than Kapton tape)
  - Easy to fix the leakage around the edge
- Test Teflon block and tape for prism part with glue
  - Difficult joint due to the difference of width
    - Prism (456mm), bar (450mm)
  - No leakage happened for 4 trials.
- Enabled to align/tune after taping

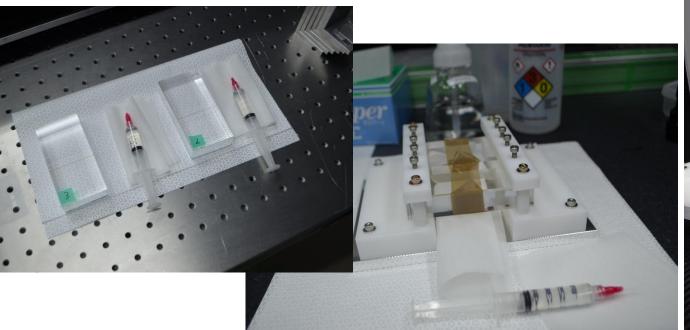
## Small polished quartz

- Made several types of EPOTEK samples and NOA63 sample as a reference
- Check the strength with the "normal" procedure
  - Alignment, taping, putting glue, curing, un-taping, cleaning the excess
- Tried to make bad samples
  - With index fluctuation by glue leakage
  - Remaining acetone residue on quartz surface
- Performed the bending test

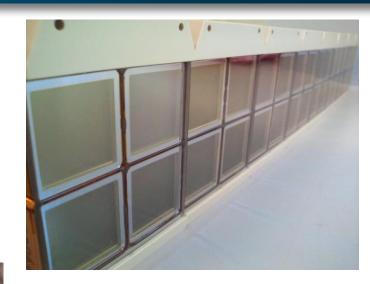
## PMT/HV/Frontend assembly

- Tested PMTs assembled to PMT modules
  - Produce optical cookies
- Install into TOP module
  - PMT modules
  - HV/Frontend electronics from US
